HOME INSPECTION SERVICE, INC.

***YOUR INSPECTION REPORT***

<b>CLIENT NAME:</b> Older Home Report.	<b>CELL PHONE #:</b> 000-333-3333.	<b>E-MAIL ADDRESS:</b> <a href="mailto:olderhome@gmail.com">olderhome@gmail.com</a> .	<b>EVALUATION ADDRESS:</b> 333 City Court.
<b>CITY, STATE, ZIP:</b> Cumming, GA 30022.	<b>DATE OF INSPECTION:</b> 00-00-2011.	<b>TIME OF INSPECTION:</b> 10:00 am.	<b>HOME / BUILDING OCCUPIED?</b> No.
<b>SOIL CONDITIONS:</b> Dry.	<b>APPROX OUTSIDE TEMP, T.O.I:</b> 50 Degrees.	<b>EST AGE OF HOUSE, BUILDING:</b> 2006.

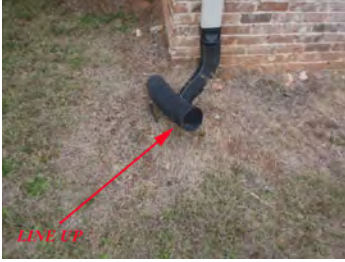
**FOUNDATION DRAINAGE CONDITION:** The visible drain line end(s) are sloped upwards and therefore will not allow it to drain by gravity. Drains shall be provided around all concrete or masonry foundations that retain earth and enclose habitable or usable spaces located below grade. Drainage tiles, gravel or crushed stone drains, perforated pipe or other approved systems or materials shall be installed at or below the area to be protected and shall discharge by gravity or mechanical means into an approved drainage system.

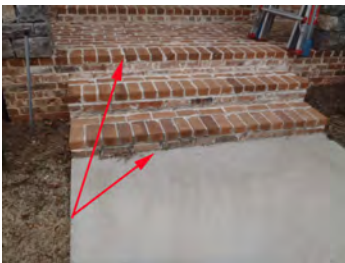
The steps are not consistent in height. The different step heights could be a trip hazard. The maximum riser height should not be more than 7 3/4". Risers (heights) and treads (widths) should not vary more than 3/8".

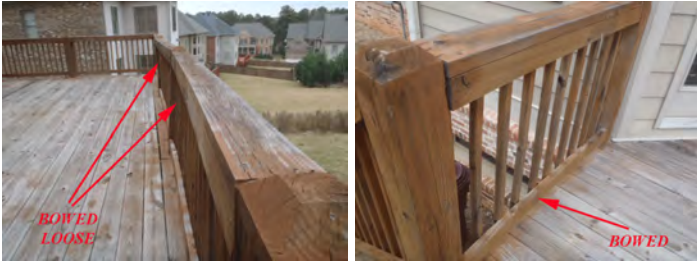
- (a). Some of the guardrail(s) members are warped / twisted, replace as needed.
- (b). Some sections of the guardrail and handrails are loose. All railing should be able to withstand 200 pounds per square foot in any direction at any point along the top, repair / replacement are recommended for safety enhancement.

1. (a). Some of the guardrail(s) members are warped / twisted, replace as needed.
- (b). Some sections of the guardrail and handrails are loose. All railing should be able to withstand 200 pounds per square foot in any direction at any point along the top, repair / replacement are recommended for safety enhancement.

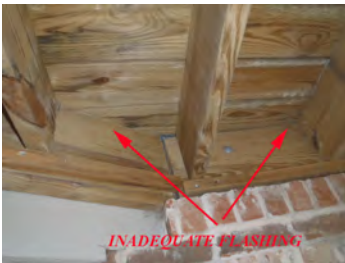
Inadequate flashing installed (not overhanging deck ledger). Approved corrosion-resistive flashing should be installed when exterior porches, decks or stairs attach to a wall or floor assembly of wood-frame construction (see Deck Detail).

2. Inadequate flashing installed (not overhanging deck ledger). Approved corrosion-resistive flashing should be install when exterior porches, decks or stairs attach to a wall or floor assembly of wood-frame construction (see Deck Detail).

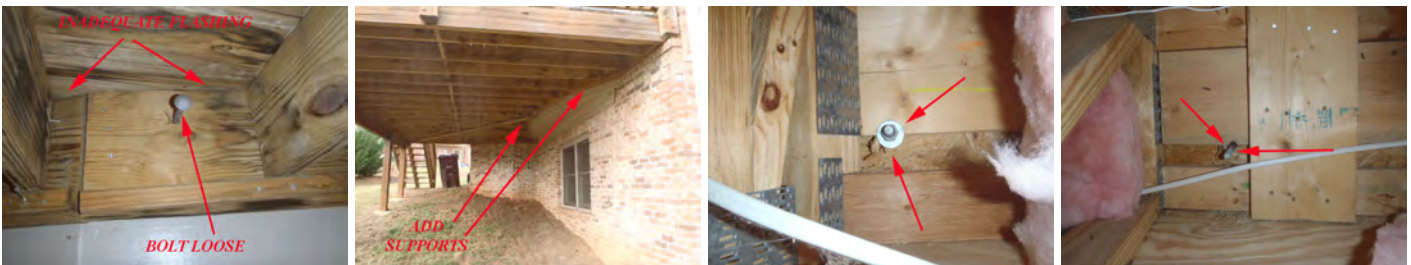
- (a). No washers / nuts installed on some of the bolts and some of the bolts are not adequately attached (visible from the basement).
- (b). The bolts are attached to sections of 2x10 installed behind the open web floor joist in the basement. Where supported by attachment to an exterior wall, decks should be **positively** anchored to the primary structure and designed for both vertical and lateral loads as applicable. The deck should be bolted with 1/2" hex thru-bolts with flat washers on both sides and spaced 12" to 24" O/C. I recommend adding adequate vertical support with adequate footings directly below the deck where it is attached to the cantilevered joists (this way the deck will be structurally independent from the home).

3. (a). No washers / nuts installed on some of the bolts and some of the bolts are not adequately attached (visible from the basement).
- (b). The bolts are attached to sections of 2x10 installed behind the open web floor joist in the basement. Where supported by attachment to an exterior wall, decks should be **positively** anchored to the primary structure and designed for both vertical and lateral loads as applicable. The deck should be bolted with 1/2" hex thru-bolts with flat washers on both sides and spaced 12" to 24" O/C. I recommend adding adequate vertical support with adequate footings directly below the deck where it is attached to the cantilevered joists (this way the deck will be structurally independent from the home).

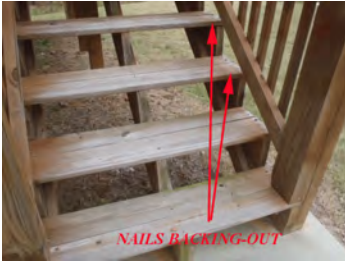
Loose step(s) observed (nails backing-out), re-nailing / re-screw as needed, repair as needed.

4. Loose step(s) observed (nails backing-out), re-nailing / re-screw as needed, repair as needed.

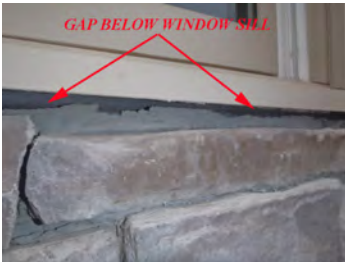
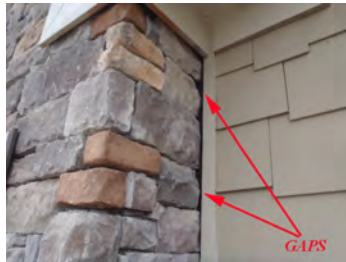
- (a). Gap observed between the stone and the foyer window sill (along bottom).
- (b). Large gaps observed between the stone and the corner boards (front center, exposed wall sheathing), repair as needed.

5. (a). Gap observed between the stone and the foyer window sill (along bottom).
- (b). Large gaps observed between the stone and the corner boards (front center, exposed wall sheathing), repair as needed.

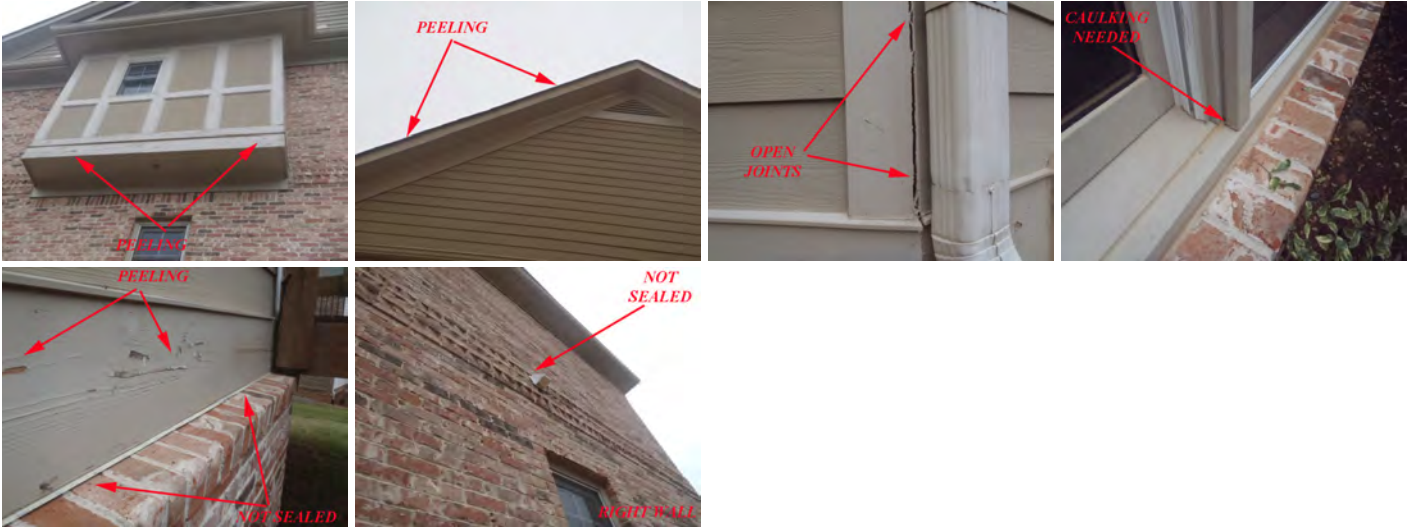
- (a). Sealing needed, back wall (flashing on top of brick ledge).
- (b). Some of the penetrations, through the exterior siding, need sealing. All corner boards, vents, wires, pipes, electrical boxes, ext; should be sealed to prevent moisture entry and air leakage.
- (c). Open joints observed in the trim around the windows and corner boards, which will allow moisture to enter and will cause deterioration over time. Proper caulking is needed at all joints.
- (d). The paint finish is peeling off some sections of the trim. The trim may not have been properly primed before the finish coat was installed. Proper caulking and painting is needed. All exterior wall should be covered with approved materials designed and installed to provide a barrier against the weather.

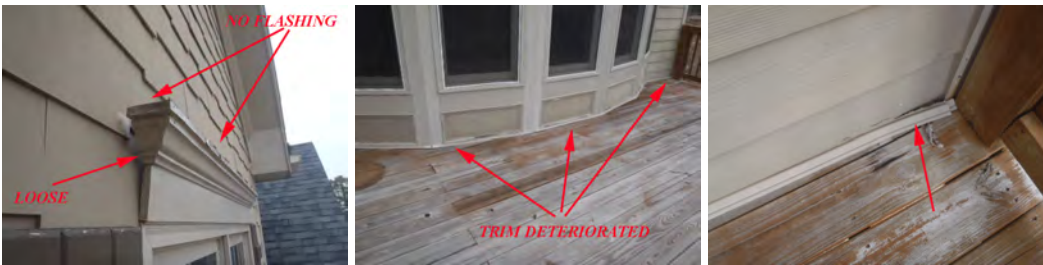
- (a). Some of the trim is deteriorated, back wall (bay window, trim along the bottom), replace as needed.
- (b). Loose section of trim observed, front wall (trim above front right bedroom window), repair as needed.

6. (a). Some of the trim is deteriorated, back wall (bay window, trim along the bottom), replace as needed.
- (b). Looses section of trim observed, front wall (trim above front right bedroom window), repair as needed.

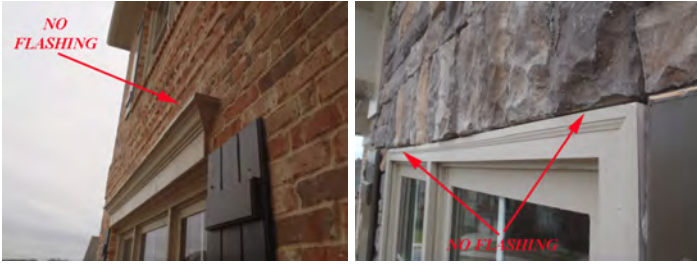
- (a). No corrosion-resistant flashing installed over the some of the windows, front wall (foyer window).
- (b). There is no corrosion-resistant flashing installed over the trim on the front wall (above the windows). Approved corrosion-resistant flashing should be installed and continuous above all **projection wood trim**.

7. (a). No corrosion-resistive flashing installed over the some of the windows, front wall (foyer window).
- (b). There is no corrosion-resistive flashing installed over the trim on the front wall (above the windows). Approved corrosion-resistive flashing should be installed and continuous above all **projection wood trim**.

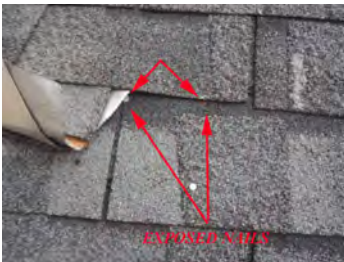
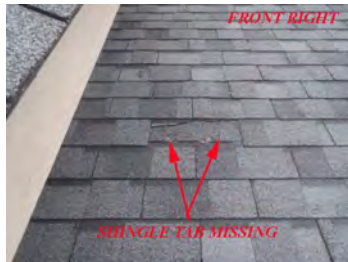
- (a). No felt installed under the shingles, small roof sections (above back bay window). Slopes of 4 in 12 or greater, one layer of felt is required over all of the roof sheathing.
- (b). Incorrect nailing observed (*exposed nails heads*). Some of the nail(s) are not being protected / covered by the upper adjacent course of shingles. A minimum of four nails per shingle is recommended. Two of the nails should be placed approximately 1" in from each end; the other two should be placed directly (5/8") above the center of each cut-out. I recommend the entire roof area be checked for incorrect nailing of the shingles.
- (c). Damage shingles observed, main roof (front right, left side). Damaged shingles could turn into a roof leak. All damaged shingles should be replaced. Roof shingles should provide a barrier against the weather to protect its supporting elements and structure beneath.

8. (b). Incorrect nailing observed (*exposed nails heads*). Some of the nail(s) are not being protected / covered by the upper adjacent course of shingles. A minimum of four nails per shingle is recommended. Two of the nails should be placed approximately 1" in from each end; the other two should be placed directly (5/8") above the center of each cut-out. I recommend the entire roof area be checked for incorrect nailing of the shingles.

(c). Damage shingles observed, main roof (front right, left side). Damaged shingles could turn into a roof leak. All damaged shingles should be replaced. Roof shingles should provide a barrier against the weather to protect its supporting elements and structure beneath.

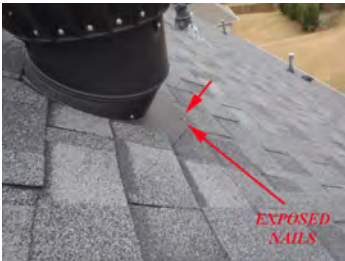
Nails noted in the exposed areas of the flashing, roof vent(s), furnace vent(s), plumbing vent(s). Nails should not be used in the exposed areas of the flashing. If and when nails are used, the nail heads should have asphalt plastic cement applied over them. Flashing against vertical walls, as well as soil stack, vent pipe and chimney flashing, should be applied according to asphalt shingle manufacturer's printed instructions.

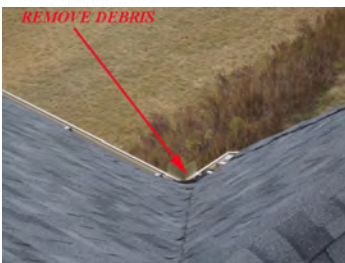
Debris in gutter(s), recommend having the gutters cleaned.

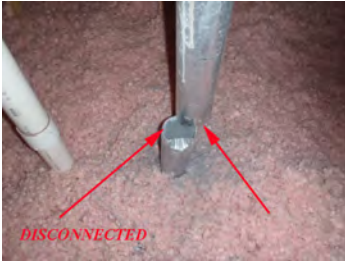
The dryer vent is disconnected in the attic. The vent needs to be connected and cleaned. *NOTE: Lint can built-up in the dryer vent over time, it should be cleaned on a yearly basis.*

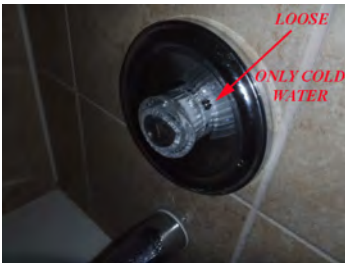
No hot water (cold only) when tested (guest bathroom), repair as needed.

10. No hot water (cold only) when tested (guest bathroom), repair as needed.

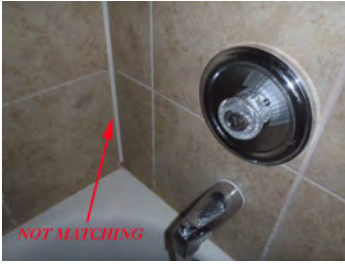
The caulking in the corners is not matching the tile (guest bathroom).

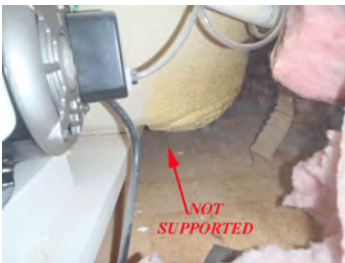
(a). No mortar / plaster installed under tub. To ensure additional support and drainage of the tub, most manufacturers recommend a bed of mortar or plaster, covered with a 2mil polyethylene sheet, be applied under the base at the time of final setting in an amount sufficient only to level the tub and not to raise it. The floor area under the tub must be capable of supporting at least 50 lb/ft and requires a 4"x12" cutout for the waste connection. The rim of the tub should not carry any weight, but should be supported.

(b). Whirlpool jets pipes and motor are in need of cleaning. NOTE: Failure to follow proper cleaning and maintenance procedures for the whirlpool bath circulation system can result in the growth and transmission of infectious bacteria. The circulation system should be flushed regularly. For more information on cleaning visit [www.us.kohler.com/tech/careamdcleaning/specialconsiderations.jsp](http://www.us.kohler.com/tech/careamdcleaning/specialconsiderations.jsp).

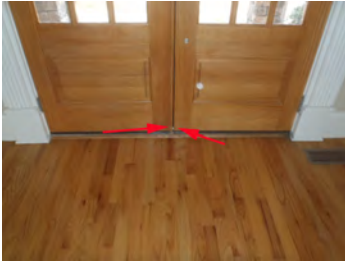
Gaps / Daylight noted in the weather stripping. Adjustments needed to prevent Air Penetration.

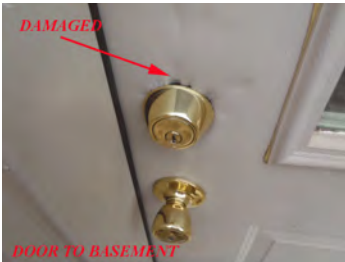
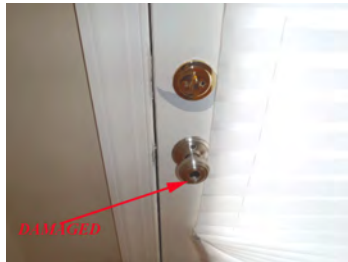
- (a). Door damaged around dead bolt (door to basement).
- (b). The hardware is damaged, back door (breakfast area), repair / replace as needed.

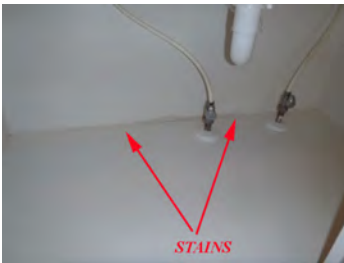
Moisture stains observed under the back sink of the master bathroom. These stains tested dry at the time of the inspection. However, I recommend you monitor these areas in the future.

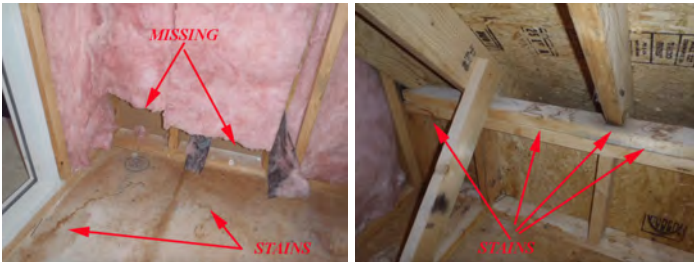
Moisture stains observed, right attic / storage area off the master closet (floor and right wall). These areas tested dry at the time of the inspection. The stains are an indication that there was a leak at some point in the past. There has not been any heavy rain in quite some time, so its possible that active leaks are present.

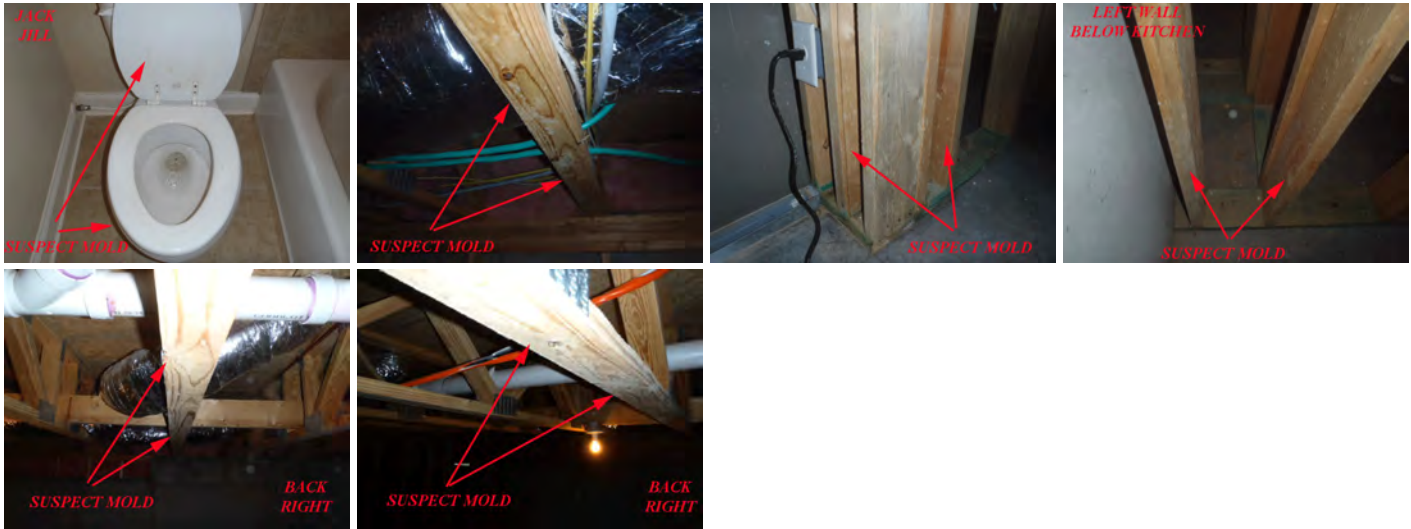
Suspect mold / mildew observed, Jack / Jill bathroom (toilet seat), basement area below the dining room (floor joist and some of the walls studs next to the furnace), basement area below the guest bedroom (bottom of some of the floor joist and some of the wall studs, left wall front area), basement center area (floor joist below the family room, check all areas). Some people are sensitive to mold / mildew and experience headaches, runny noses, skin rashes, nausea, sinus problems. The U.S Environmental Protection Agency has created a publication to provide information and guidance for homeowners and renters on how to clean up residential mold problems and how to prevent mold growth. The publication is titled Brief Guide to Mold, Moisture and Your Home and can be found on the Web site at [www.epa.gov/iaq/molds/moldguide.html](http://www.epa.gov/iaq/molds/moldguide.html). Due to the health hazards relating to mold / mildew, I recommend it be tested by a Certified Mold Inspector to determine the type of mold and the hazards relating to it (Mold / Mildew testing is beyond the scope of this inspection). After testing appropriate steps should be taken to correct the mold / mildew condition within the home. Note: The first floor furnace is located in the basement area, I recommend it also be checked for mold activity.

13. Suspect mold / mildew observed, Jack / Jill bathroom (toilet seat), basement area below the dining room (floor joist and some of the walls studs next to the furnace), basement area below the guest bedroom (bottom of some of the floor joist and some of the wall studs, left wall front area), basement center area (floor joist below the family room, check all areas). Some people are sensitive to mold / mildew and experience headaches, runny noses, skin rashes, nausea, sinus problems. The U.S Environmental Protection Agency has created a publication to provide information and guidance for homeowners and renters on how to clean up residential mold problems and how to prevent mold growth. The publication is titled Brief Guide to Mold, Moisture and Your Home and can be found on the Web site at [www.epa.gov/iaq/molds/moldguide.html](http://www.epa.gov/iaq/molds/moldguide.html). Due to the health hazards relating to mold / mildew, I recommend it be tested by a Certified Mold Inspector to determine the type of mold and the hazards relating to it (Mold / Mildew testing is beyond the scope of this inspection). After testing appropriate steps should be taken to correct the mold / mildew condition within the home. Note: The first floor furnace is located in the basement area, I recommend it also be checked for mold activity.

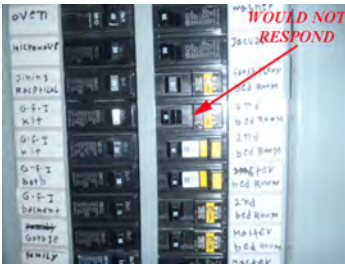
One of the Arc-Fault breakers would not respond to the test button. All branch circuits that supply 125-volt, single-phase, 15 and 20 ampere receptacle outlets installed in dwelling unit bedrooms should be protected by an arc-fault circuit interrupter listed to provide protection of the *entire branch circuit*. **Definition:** *An arc-fault circuit interrupter is a device intended to provide protection from the effects of arc faults by recognizing characteristics unique to arcing and by functioning to de-energize the circuit when an arc fault is detected.* Have a licensed electrician make further evaluation and corrections as needed.

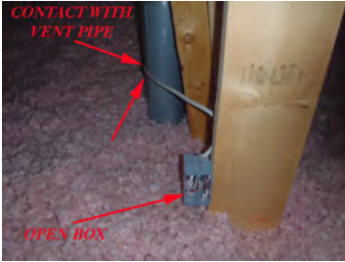
- (a). Cable in contact with the basement furnace vent pipe (attic area).
- (b). Open junction box, attic area (left side, center area). All boxes should have a cover, faceplate, or fixture canopy.

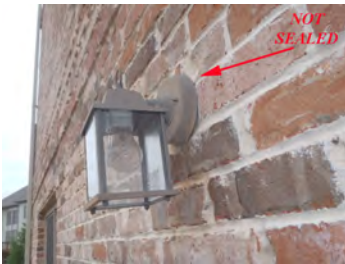
- (a). Covers missing of the light fixture, master sitting area, closet (front right bedroom), install as needed.
- (b). Lights are not operational in some areas, garage (left side), hallway's (both floors), basement (some areas), attic / storage areas off the master closet (both sides), possibly due to bad bulbs or no bulbs, have them checked.
- (c). The exterior light fixtures (*boxes*) are not weatherproof (*gaps noted*). In damp or wet locations, boxes, conduit bodies and fittings should be placed or equipped so as to prevent moisture from entering or accumulating within the box, conduit body or fittings.

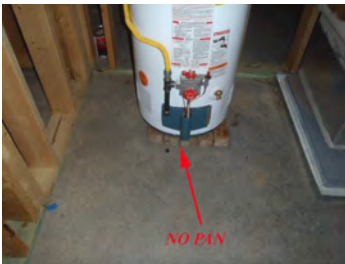
No pan installed under the water heater.

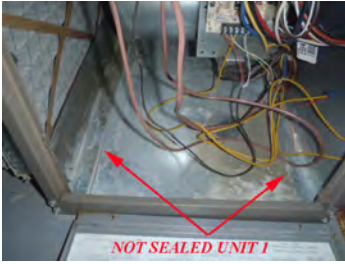
- (a). Unit 1 (basement): The bottom of the cabinet is not sealed (*gaps between the bottom of the furnace and the catch pan*). This condition is allowing unfiltered air to be taken from the attic. This item should be addressed when the units are being serviced.
- (b). Both units responded to normal operating controls. However, I recommend having both furnaces cleaned and serviced by a Licensed Heat/Air Contractor. Obtain a work-order showing this service has been performed. *Note: Heating and cooling system should be service annually.*

16. (a). Unit 1 (basement): The bottom of the cabinet is not sealed (*gaps between the bottom of the furnace and the catch pan*). This condition is allowing unfiltered air to be taken from the attic. This item should be addressed when the units are being serviced.
- (b). Both units responded to normal operating controls. However, I recommend having both furnaces cleaned and serviced by a Licensed Heat/Air Contractor. Obtain a work-order showing this service has been performed. *Note: Heating and cooling system should be service annually.*

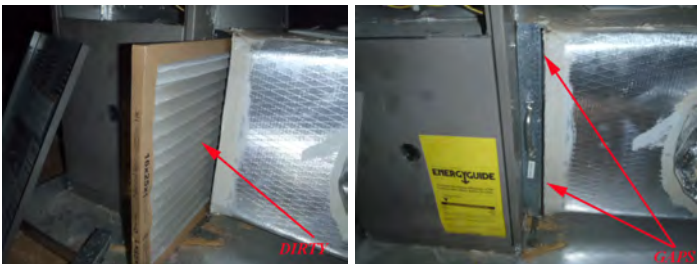
(a). The filter / filters are dirty, change as needed. **Note:** *Clogged / Dirty filter(s) impede the flow of air through the furnace.*

(b). Gaps noted around the filter cover. Cover(s) should be installed to prevent unfiltered air from going around the filter. *See service comments above.*

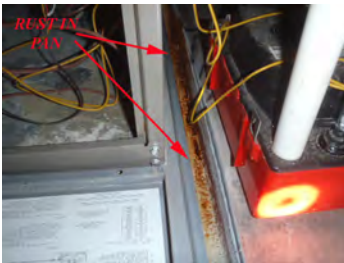
Rust observed in the catch pan below the furnace (Unit 1, basement). It appears the unit leaked at some point in the past. See service comments / recommendations.

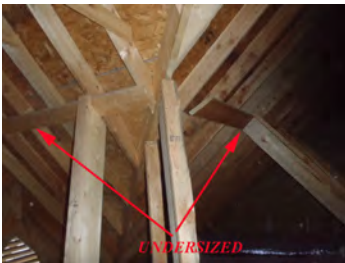
Purlins are the correct size but are installed on the flat, should be installed on edge. The lumber (2x6's) have no real structural strength when installed on the flat. Purlins should be sized no less than the required size of the rafters they support.

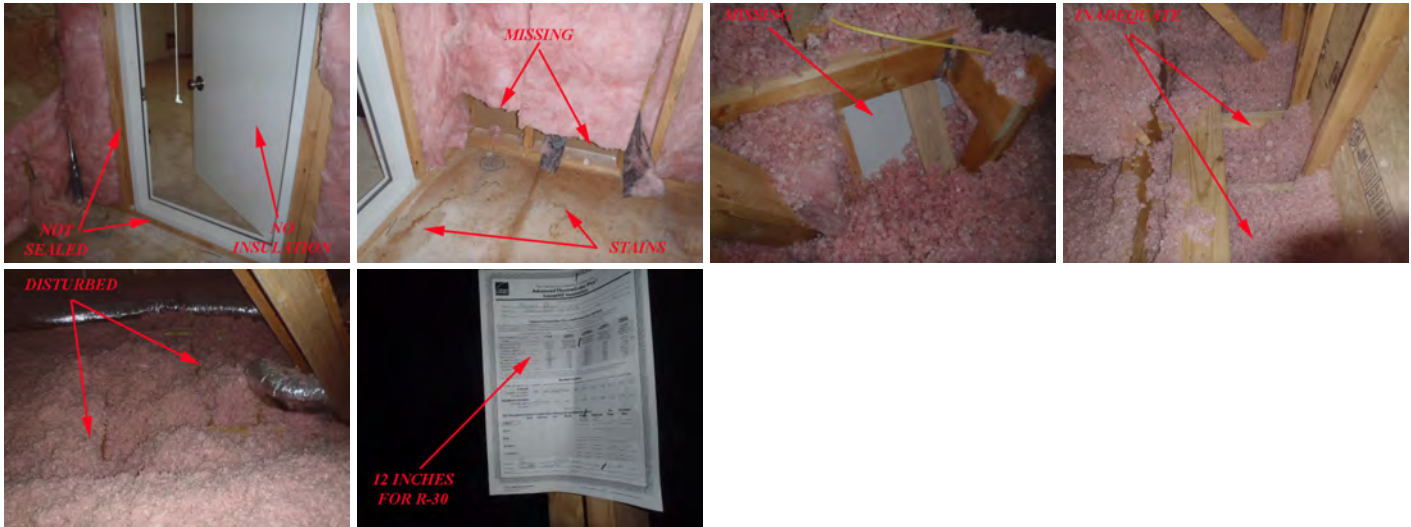
- (a). Sections of insulation missing, attic / storage area off master closet (right side, back wall).
- (b). No rigid insulation installed, door(s) to the attic / storage area off the master closet (see Infiltration Control Detail).
- (c). No backer rod / spray foam (*appropriate for window /doors*) installed between the attic door(s) (*master closet*) and the rough opening (see Infiltration Control Detail).
- (d). No weather stripping / rigid insulation box installed above the attic pull-down stairs (see Infiltration Control

(e). Inadequate insulation installed in several areas. The insulation certification card call's for 12 inches for R30. The card is to verify the attic has the proper amount of insulation. The insulation installer should provide a signed and dated certification for the insulation installed, listing the type of insulation, the manufacturer and the R-value.

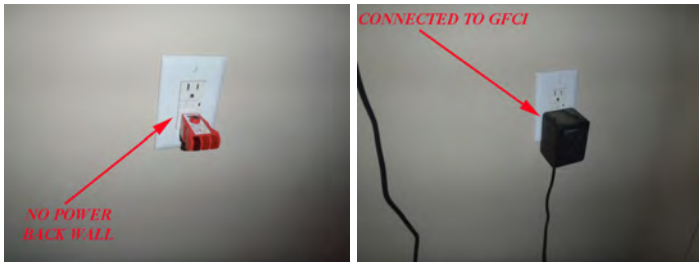
- (a). No power at the GFCI outlet (back wall), repair / replace as needed.
- (b). The sprinkler system is plugged into one of the GFCI's outlets. Be aware if the circuit trips "OFF", then this units will not function. I recommend installing a single or special purpose outlet for the sprinkler system.

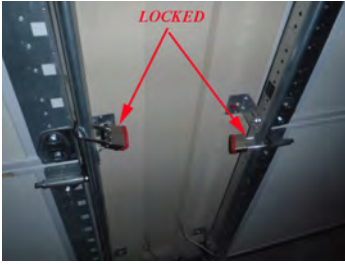
Doors locked at the time of inspection, could not inspect (have checked before closing).

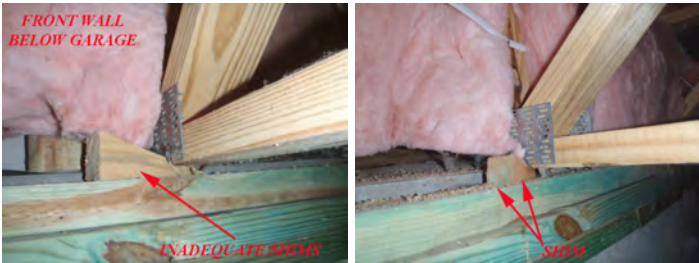
- (a). See mold comments / recommendations.
- (b). Some of the floor joist have inadequate shims installed under the bottom chord, back right (area below the door to the garage). I recommend installing adequate shims between the top plate and the bottom of the floor joist. Note: The end of the joist is sitting on the foundation.

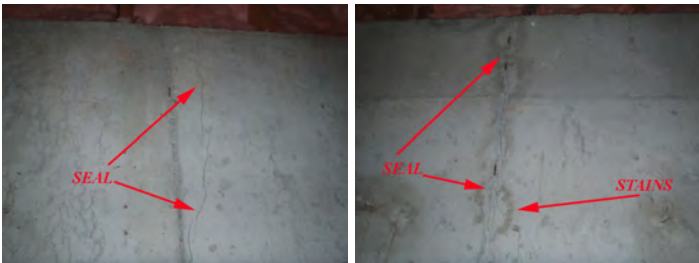
Cracks observed in the exposed wall area. I recommend cracks be sealed and monitored for further movement. If cracks reappear or get larger, consult with a structural engineer. See basement moisture comments / recommendations.

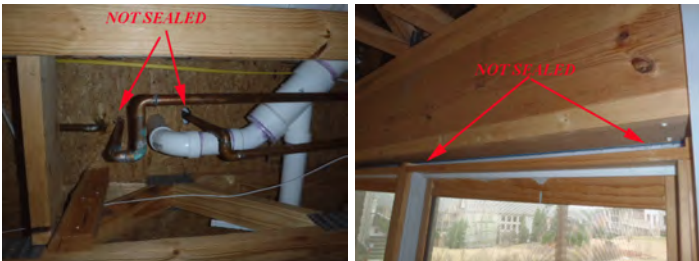
- (a). Some of the key points have not been sealed, plate / wall penetrations, window / door rough openings, wiring and plumbing penetrations, HVAC penetrations, etc.
- (b). The basement exterior concrete foundation wall(s) are not insulated. When this home was built the builder had a choice to insulate the basement ceiling or All the exterior wall(s). Basement concrete foundation walls should be insulated with a minimum of R-5 insulation.

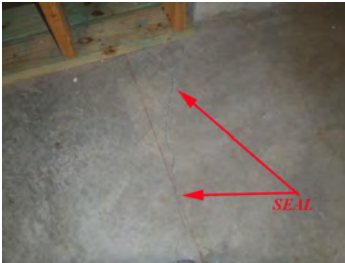
Cracks noted in the exposed floor area. I recommend cracks be sealed and monitored for further movement. If cracks reappear or get larger, consult with a structural engineer.

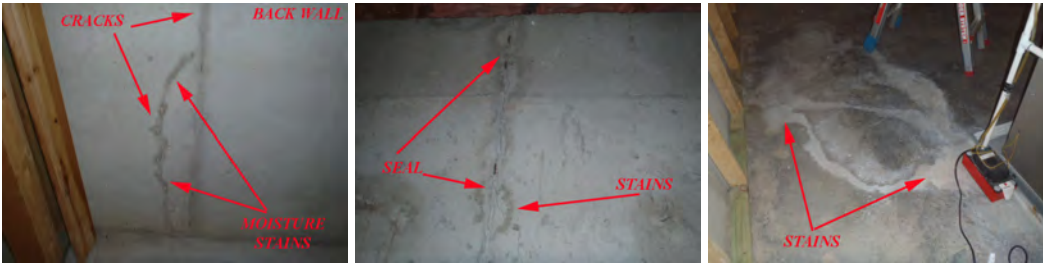
- (a). Stains observed on the floor next to the furnace.
- (b). Moisture observed around some of the cracks in the exterior foundation walls (areas around the cracks). I recommend all moisture entering the basement area be eliminated by a qualified contractor and the builder provide you with an extended warranty on the repairs. Note: These areas were dry at the time of the inspection.
